PROPERTY INSPECTION REPORT

Customer Name: Steve Johnson
Property Address: 123 Pennsylvania Way
York, PA 17408
Account Number: 27534

Report Number: 27534	Client: Steve Johnson
Property Address: 123 Pennsylvania Way, York, PA 17408	
Weather Conditions: Sunny	Temperature: 80 degrees
Approximate Age of Structure: 25 years	Approx. Age of Roof: #1 10 years #2 years
Inspector: Steve Johnson A.S.H.I. #: 115821	Date of Inspection: 9/2/2010 Time In: 9:00am Time Out: 1:00pm

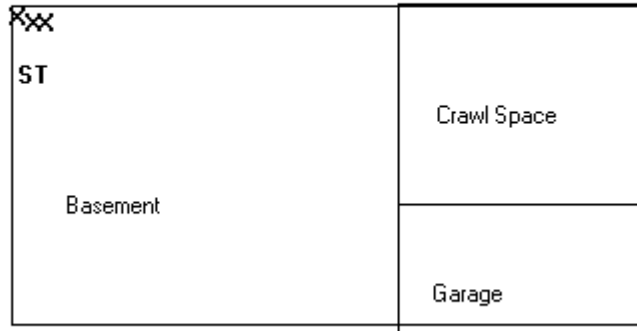
Visible Damage / Wood Destroying Insect Activity: Old inactive termite damage to floor joist in left rear corner of basement.

The visible damage due to wood destroying organisms noted on the above graph does not appear to affect the structural integrity of the area where the damage was found. The damage noted above is cosmetic in nature not structural. The inspected property appears to be structurally sound as it pertains to the visible damage found and noted on the above graph.
