## Residential Property Inspection|PA Report

LOCATED AT:  
6130 Poplar Path, Elizabethtown, PA 17022

INSPECTED ON:  
6/25/2026 09:00:00 AM

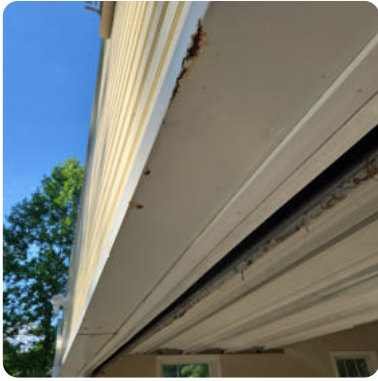
The garage vehicle door jamb is improperly flashed and capped, allowing water intrusion. Visible deterioration and rust corrosion are present on the capping material. Further evaluation and corrections by a qualified specialist are recommended.

Corrections are recommended. Repairs or replacement should be performed by a qualified specialist.

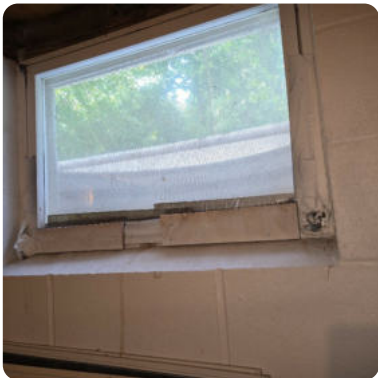
**Location: Basement units**

**Exterior Windows****Moisture Damage Observed**

Corrections are recommended. Repairs or replacement should be performed by a qualified specialist.

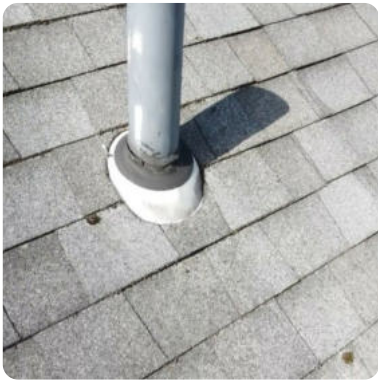
**ROOF****Penetration Flashing****Roof Pipe Flashing Damaged**

Pipe flashing, sometimes referred to as a roof boot, is manufactured to seal tightly around small ventilation pipes, plumbing, and other vents and equipment that protrude from the roof of a home or commercial building. The flashing is necessary to prevent leaks. The base is typically a flexible metal so that it is compatible with virtually any roofing material.

Corrections are recommended. Repairs or replacement should be performed by a qualified specialist.

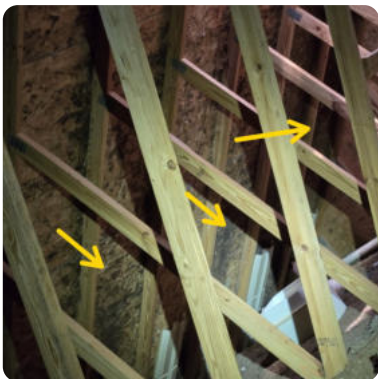
**Location: 2nd Floor, Attic, Rear, Right**

**Attic****Attic General Conditions****Microbial Growth Observed**

Microbial growth, often referred to as mildew or mold, is a family of fungi that is commonly found both indoors and outdoors. Microbial growth indoors occurs when there is high humidity or moisture, low sunlight, oxygen, the right temperature, and organic matter present. Since microbial growth can be found everywhere, and it is constantly reproducing, all of us are exposed from the air we breathe, both indoors and outdoors, daily. It is suggested to have qualified specialist further evaluate and make corrections as needed.

Further evaluation by a qualified specialist is recommended. Address any corrections as needed based on findings.

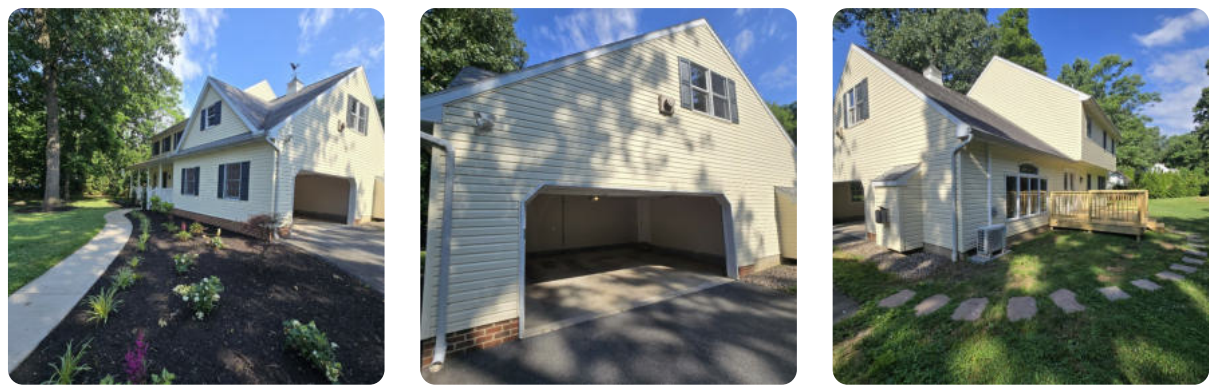
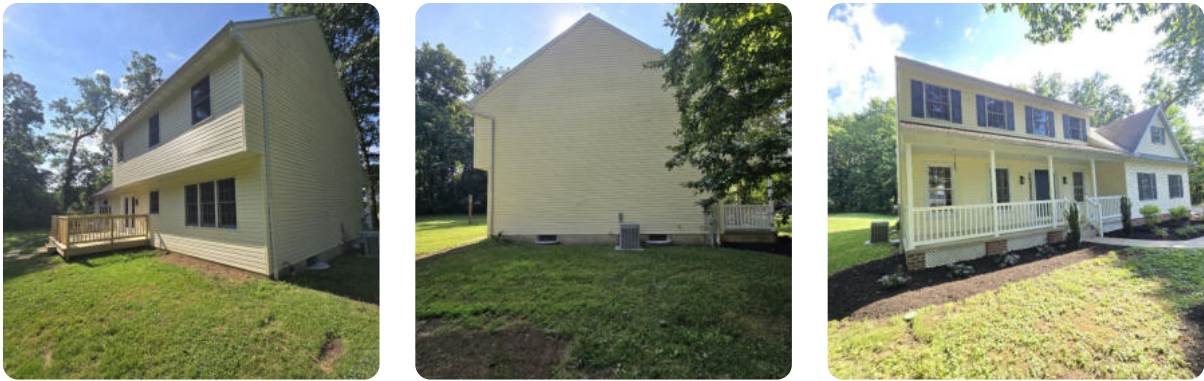
**Improper Soil Slope Toward Foundation**

This condition adds to the potential of moisture penetration and/or water entry in basements, crawl spaces, windows and doorways of a structure. It is suggested that proper regrading of the soil adjacent to the foundation at the areas noted in your report be completed. Soils should slope away from the structure at a rate of one inch per foot for at least the first six feet.

Corrections are recommended. Repairs or replacement should be performed by a qualified specialist.

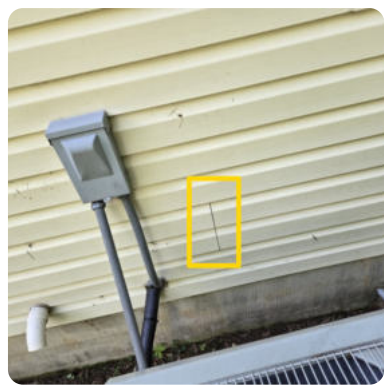
Location: Behind air conditioning unit

## Openings In Siding Observed

Corrections are recommended. Repairs or replacement should be performed by a qualified specialist.

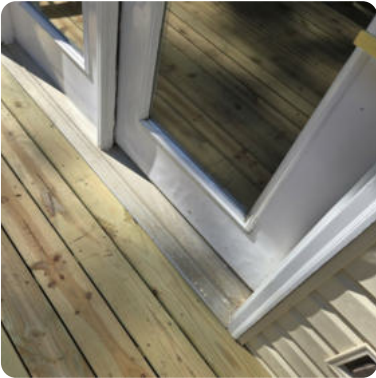
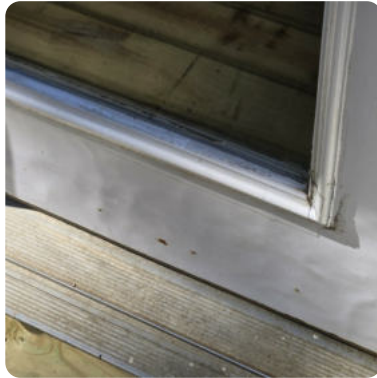
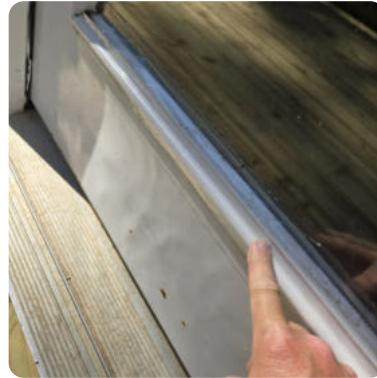
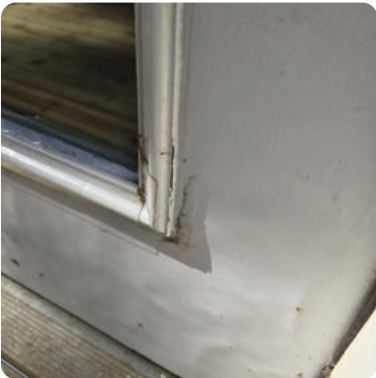
**Entry Door Damaged****Location: Rear**

**Notes :** Moisture appears to be entering around the trim, causing core damage and some rusting. Further evaluation and corrections are suggested.

Corrections are recommended. Repairs or replacement should be performed by a qualified specialist.

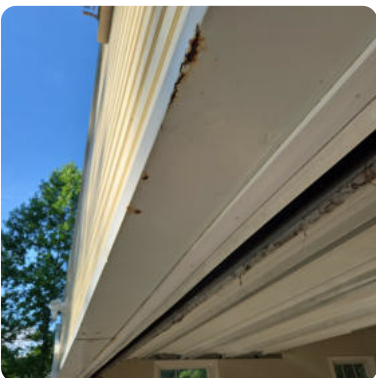
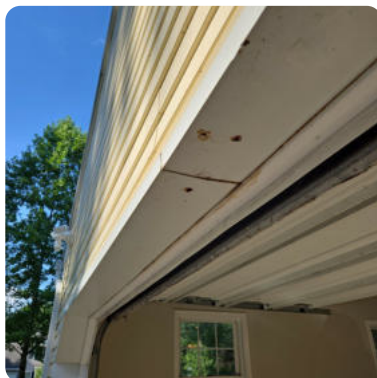
The garage vehicle door jamb is improperly flashed and capped, allowing water intrusion. Visible deterioration and rust corrosion are present on the capping material. Further evaluation and corrections by a qualified specialist are recommended.

Corrections are recommended. Repairs or replacement should be performed by a qualified specialist.

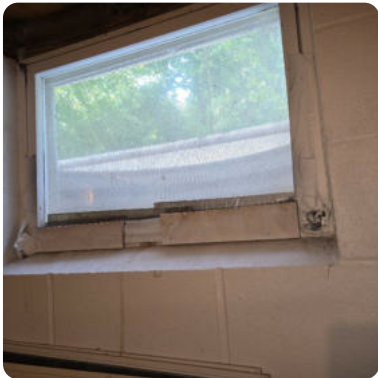
Location: Basement units

Moisture Damage Observed

Corrections are recommended. Repairs or replacement should be performed by a qualified specialist.

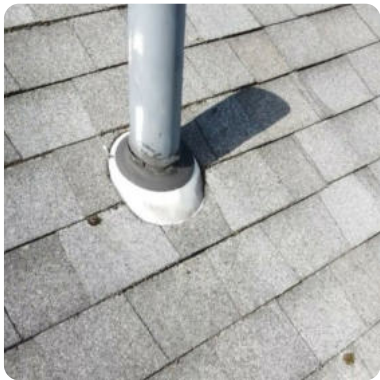
Roof Pipe Flashing Damaged

Pipe flashing, sometimes referred to as a roof boot, is manufactured to seal tightly around small ventilation pipes, plumbing, and other vents and equipment that protrude from the roof of a home or commercial building. The flashing is necessary to prevent leaks. The base is typically a flexible metal so that it is compatible with virtually any roofing material.

Corrections are recommended. Repairs or replacement should be performed by a qualified specialist.

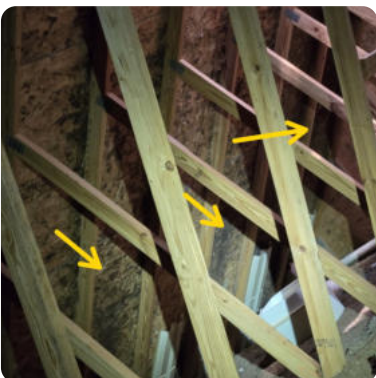
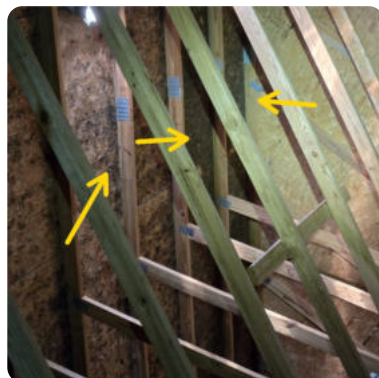
**Location: 2nd Floor, Attic, Rear, Right**

Microbial growth, often referred to as mildew or mold, is a family of fungi that is commonly found both indoors and outdoors. Microbial growth indoors occurs when there is high humidity or moisture, low sunlight, oxygen, the right temperature, and organic matter present. Since microbial growth can be found everywhere, and it is constantly reproducing, all of us are exposed from the air we breathe, both indoors and outdoors, daily. It is suggested to have a qualified specialist further evaluate and make corrections as needed.

Further evaluation by a qualified specialist is recommended. Address any corrections as needed based on findings.

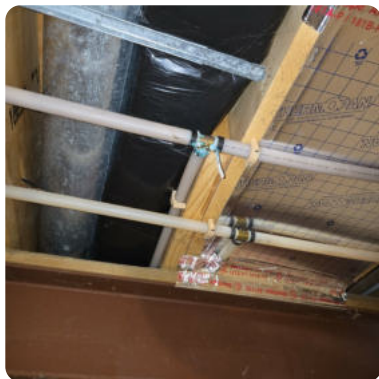
### Moderate Water Supply Pipe Rust & Corrosion Observed

Moderate rust and corrosion were observed on portions of the water supply piping. While no active leaks were noted at the time of inspection, the condition indicates ongoing deterioration that may affect pipe integrity over time. Future repairs and/or replacement should be anticipated.

Monitor this condition and address if changes occur.

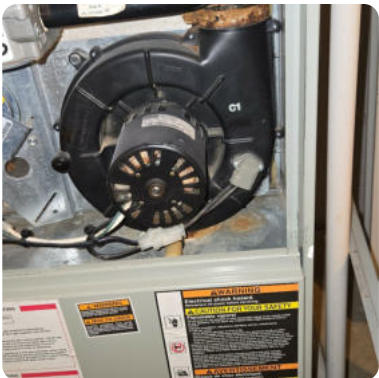
Evidence Of Past Condensate Leakage Observed

Evidence of previous condensate leakage was observed at the heating system, including signs of moisture-related staining, rust, and/or corrosion. No active leakage was observed at the time of inspection.

Monitor the condition and address if performance declines or conditions change.

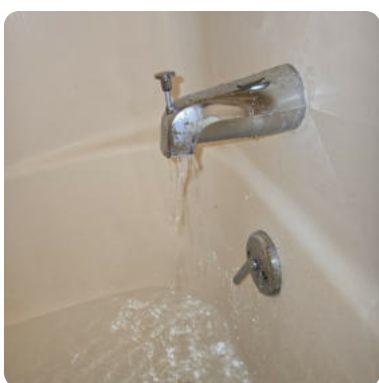
### Excessive Water Coming Out Of Tub Spout When Tee Diverter Is Activated.

This usually occurs when the O-Ring or control valve starts to deteriorate. It is suggested to repair and/or replace the tub spout. Just a side note. A leaking tub spout may also be caused from high water pressure.

Routine maintenance is recommended. Routine maintenance includes normal upkeep such as minor repairs, adjustments, cleaning, or replacement of small components (e.g., caulking, filters, screens). These items are part of homeownership and are not considered significant defects.

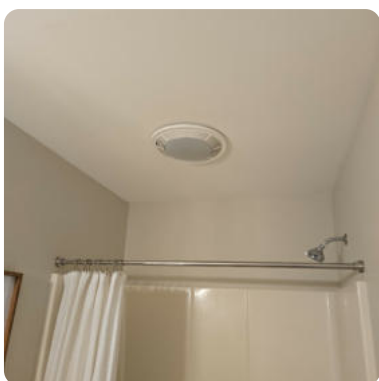
One or more light bulbs or tubes were burned out and/or missing at the time of the inspection. The fixture could not be fully evaluated without a functional bulb or tube installed.

Maintenance is recommended. This condition should be serviced or maintained as part of normal property upkeep.
